Manhole Inspection Summary

Manhole # S37A2_003MH

Location Address: **3928 2nd St.**

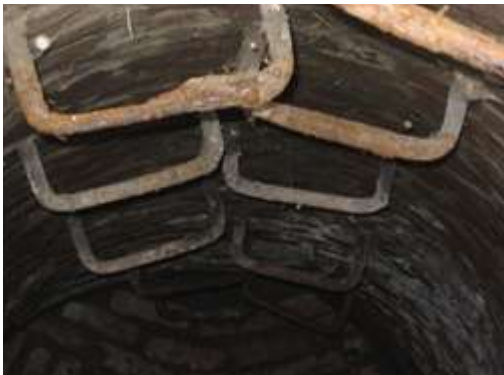
Steps

Count: **10** Missing: **0** ☐ Corroded

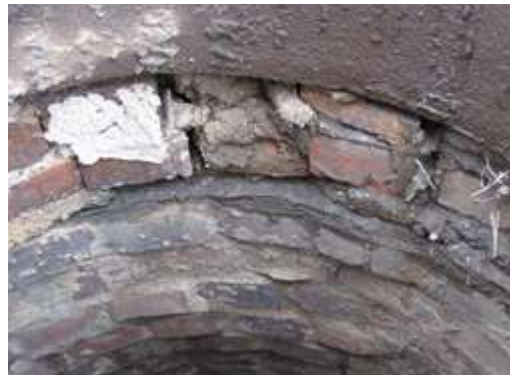
Defect 1

Condition: ☐ Sound ☒ **Cracked** ☐ Root Intrusion ☐ Loose Brick ☐ Deteriorated

Chimney(Cracked)

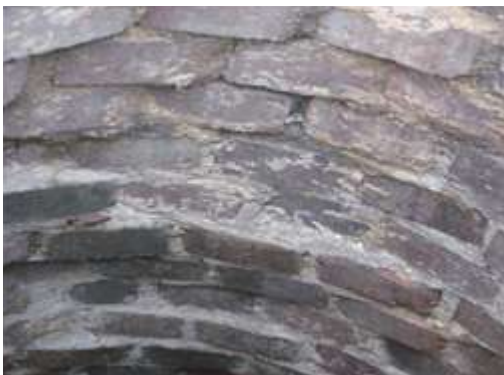
Defect 2

Infiltration: ☐ None ☒ **Joint** ☒ **Cracks** ☐ Mortar ☐ Roots ☐ Wall

Infiltration

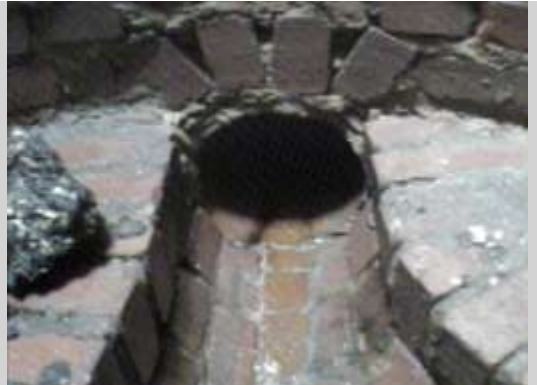
12 O'Clock Outflow

Pipe Height: **8.4** (in.) Rod and Bar (Angled)
Pipe Material: **Clay** ☐ Pipe Lined
Invert Depth: **14.50** (ft.) Flow Characteristics: **None**
Deposits: ☒ None ☐ Mud ☐ Sludge ☐ Debris ☐ Grease
Silt Depth: (in.) Deposits Extent:
Infiltration: **None** Pipe Seal Cond: **Sound**

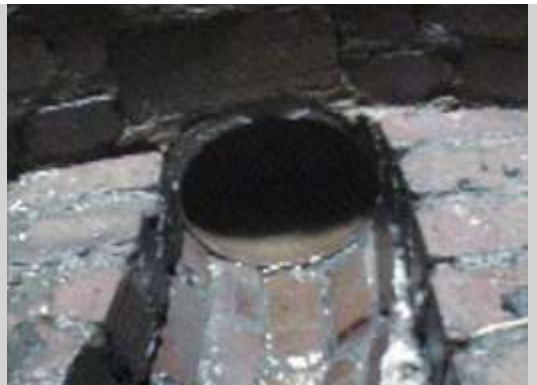
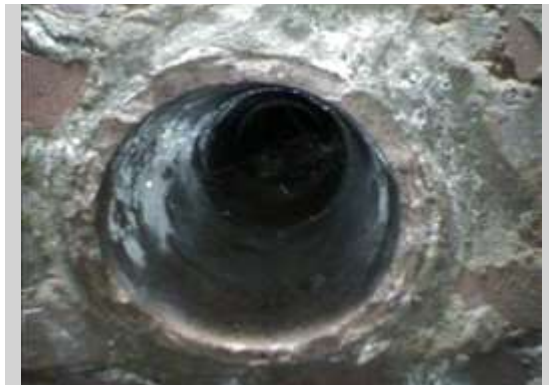
3 O'Clock Inflow

Pipe Height: **8.4** (in.) Rod and Bar (Angled)
Pipe Material: **Clay** ☐ Pipe Lined
Invert Depth: **9.72** (ft.) Flow Characteristics: **None**
Deposits: ☒ None ☐ Mud ☐ Sludge ☐ Debris ☐ Grease
Silt Depth: (in.) Deposits Extent:
Infiltration: **None** Pipe Seal Cond: **Unknown**

Drop: **Outside** Rod and Bar
Angled: **Yes** Reading: **13.35** (ft.)
Inv Depth: **14.35** (ft.)

Drop Condition: **Open**

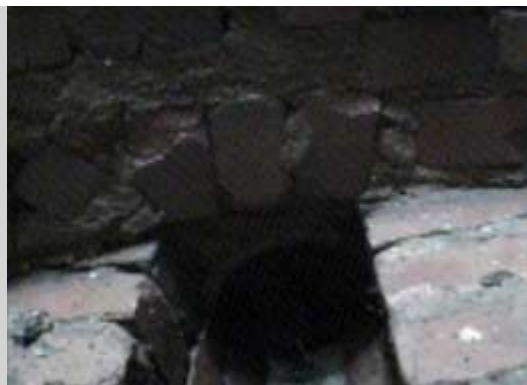
8 O'Clock Inflow

Pipe Height: **8.4** (in.) Rod and Bar (Angled)

Pipe Seal Cond: **Unknown**
